Technical Bulletin		Model 911 C2/C4	Group 2
Subject:	Ignition Cables Chafe on Ground Strap	Part Identifier 2855	Number 9201

Models Affected: **911 Carrera 2/4**
Model years '89 (K), '90 (L) and '91 (M)

Concern: Ignition cables from the ignition coils to the ignition distributors may chafe on left engine lid hinge ground strap.

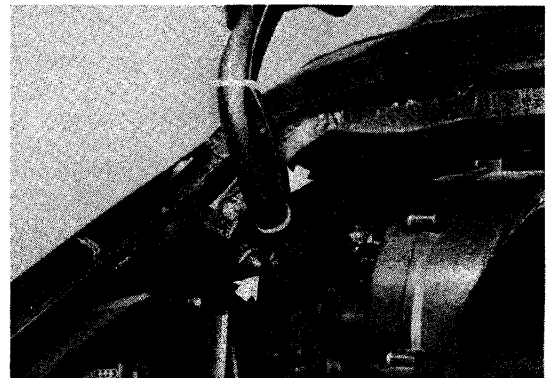
New Routing
Figure 2

Vehicle Information: Routing of the ground strap on the left engine lid hinge was changed in production as of April 15, 1991 (Figures 1 and 2).
