Technical Bulletin

Subject: **Sealing Pipe Connections
on Expansion Valve**

Number
9401

Models Affected: *911 Carrera 2/4 1989-on
911 Turbo 1991-on
911 Carrera 1995*

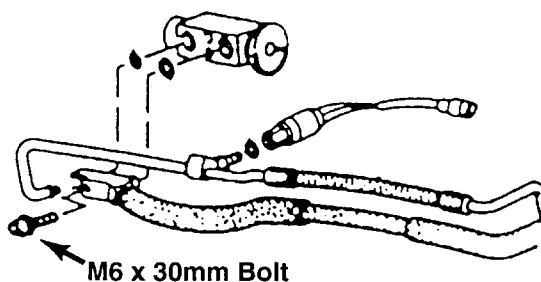
Figure A

Concern: Under certain circumstances, refrigerant loss from the area of the expansion valve pipe connections can be misdiagnosed as a defective expansion valve.

General Information: As of production date 10/93, a longer bolt has been used in the installation of the A/C lines to the expansion valve. The new bolt is installed as a precaution to prevent the expansion valve from distorting which could cause a leak at the pipe connections on the expansion valve.

Repair Information: Use the new bolt, M6 x 30mm (see Figure A), when repairs to the expansion valve are necessary. The torque specification for the bolt is 10Nm. **Do not exceed this torque.**
